# **New Jersey Department of Transportation**

## **FACILITIES ADA SITE INSPECTIONS**

### **(Updates and Recommendations)**

## **2023**

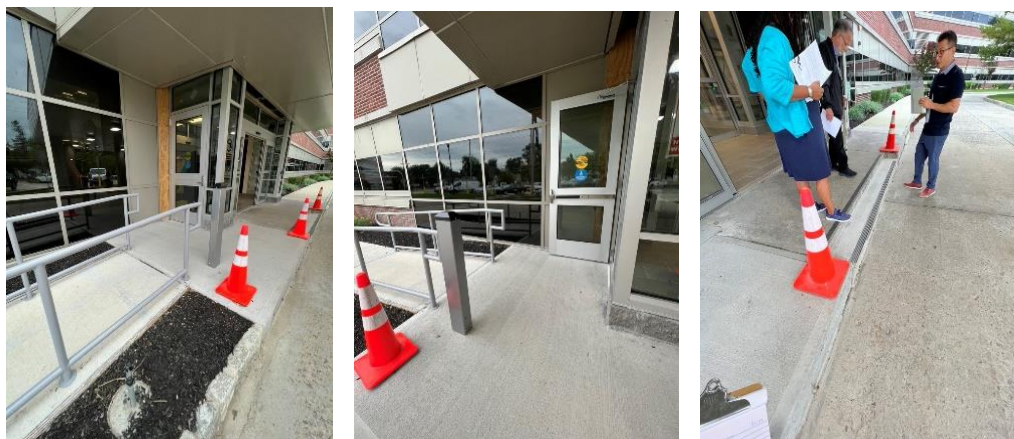
- 1) At the time of the site inspection, the entrance was under construction. After construction, there will be two yellow bollards placed on each side of the entrance, totaling four for ADA accessibility identification.

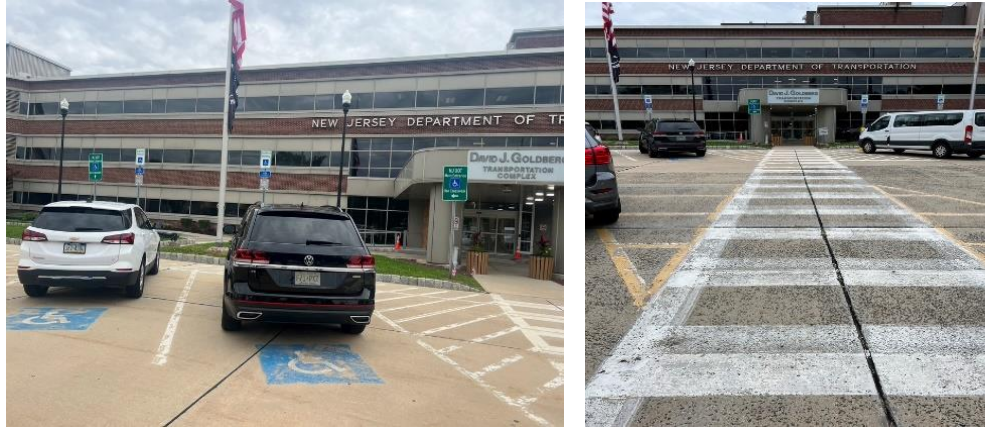
- 2) Recommended restriping accessible parking space in front of MOB.

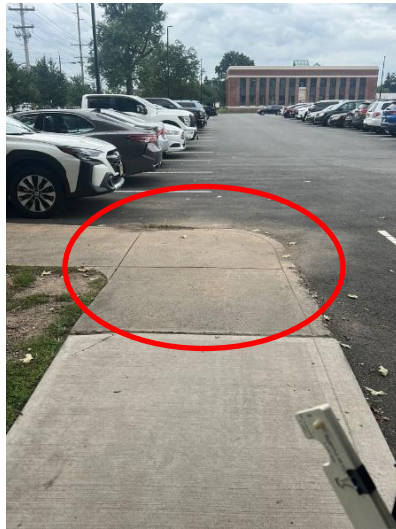
- 3) Recommended installing a Detectable Warning Surface (DWS) on the sidewalk from Lot B toward MOB.

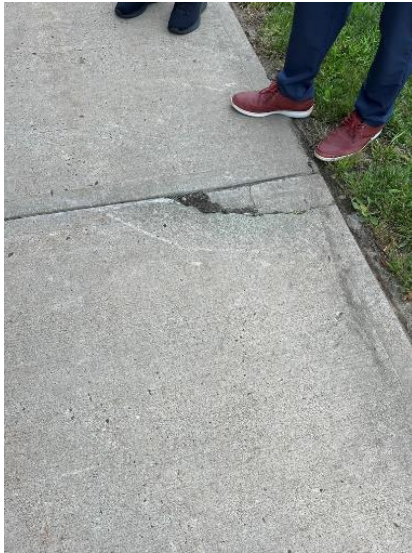
- 4) Deteriorated concrete sidewalk poses a tripping hazard and will be repaired.

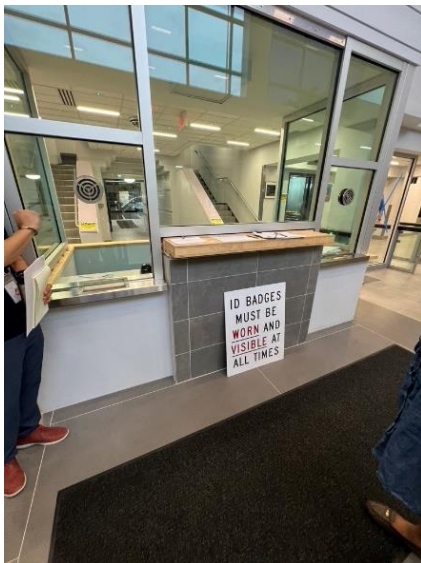
- 5) Security sign-in station: It is recommended that a table be permanently provided for ADA accessibility between 27in. - 34in. in height.

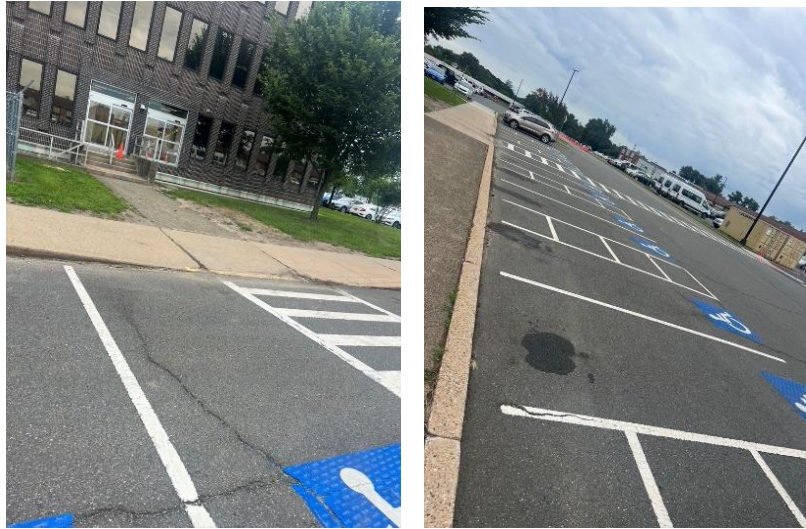
- 1) The new F&A entrance will be complete by March 2024.

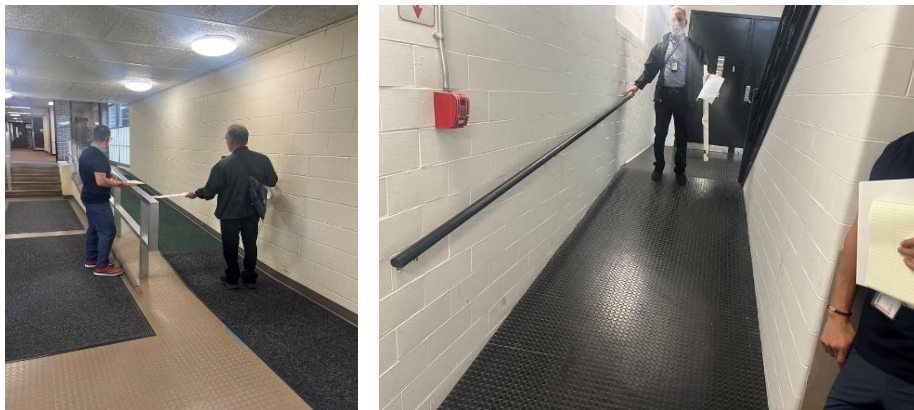
- 2) It is recommended that a handrail be installed along ADA ramp at entrance/exit near security station.  
(See picture on the left) ↓

- 4) It is recommended that an additional handrail be installed along ADA ramp between MOB and F&A. (Handrail should be on both sides) (See picture on the right) ↑

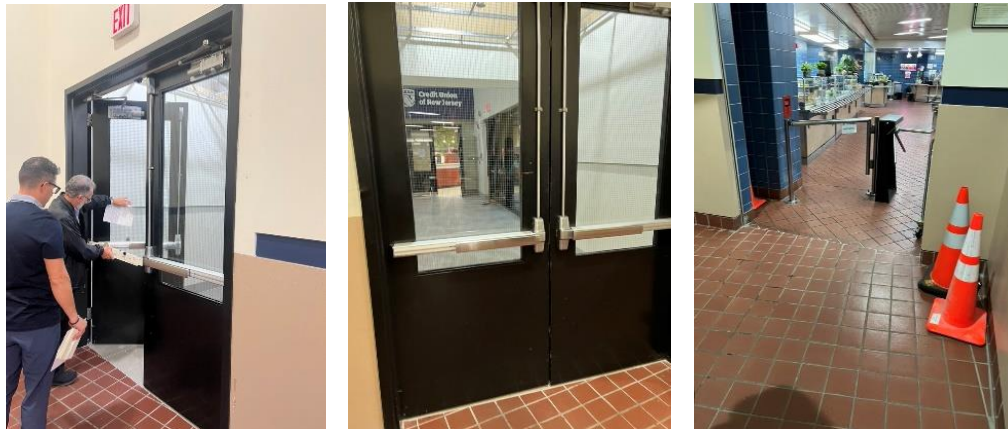
- 1) One automatic ADA accessible push-button door will be installed at the main entrance to the cafeteria.
- 2) The cafeteria entrance door (near Credit Union) will be replaced and calibrated to comply with opening and closing forces for ADA compliance. One automatic door ADA accessible push-button door will be installed.

**Update: On October 30, 2023, automatic ADA accessible push-buttons were installed at cafeteria doors.**

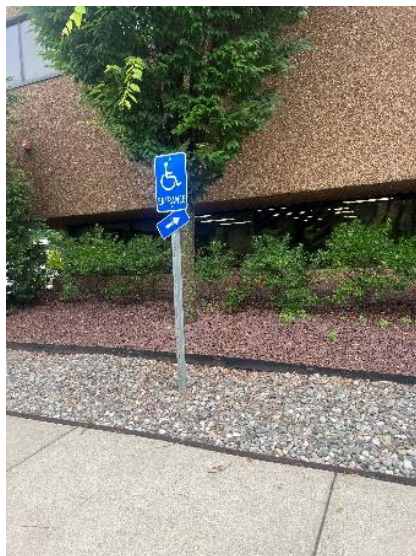
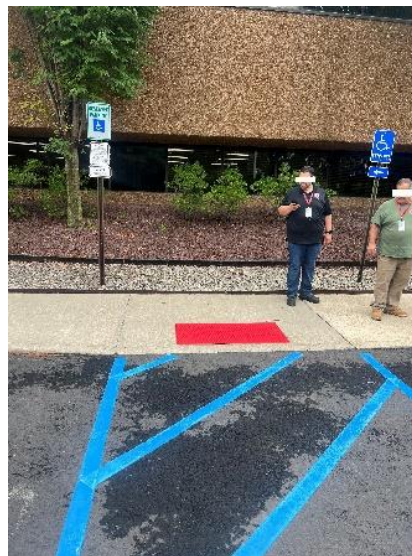
- 1) An accessible parking sign will need to be tightened. Currently, part of the sign is off-centered.

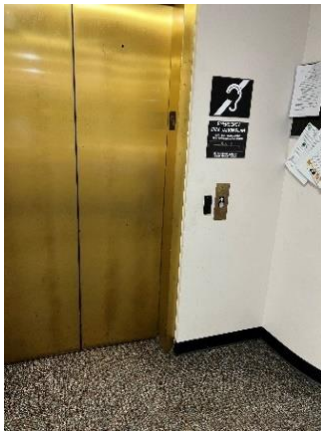
(First Floor)

- 3) It is recommended that deaf individual(s) signage be installed on the first and second floors, near the elevator.

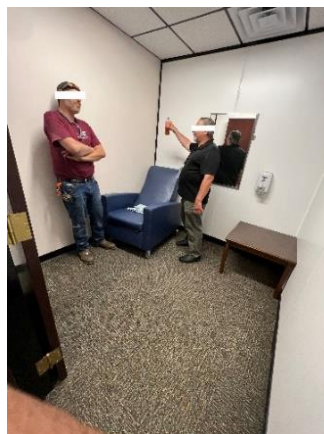
- Recommend installing a sink for sanitary purposes.

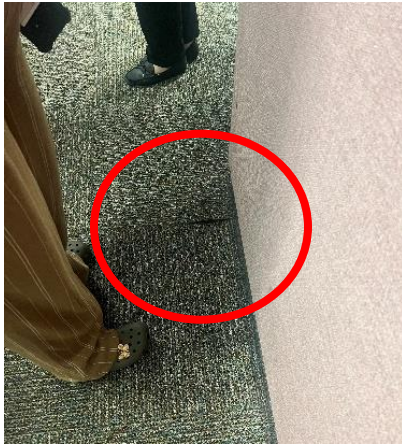
- 5) There is a hole in the carpet on the second floor which may pose a tripping hazard. It is recommended that the carpet/floor be repaired to comply with ADA accessibility standards.

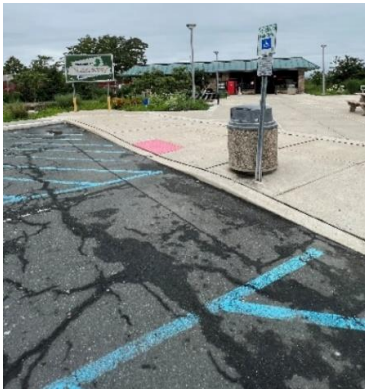
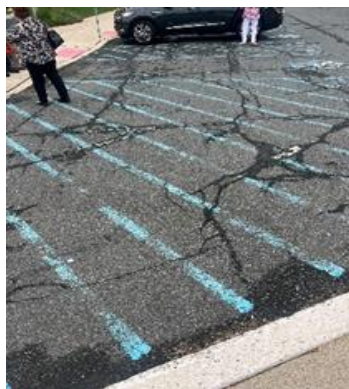
- 1) There are four detectable warning surfaces (DWS) along the front of the building that should be replaced due to deterioration.

- 2) Accessible parking spaces should be repainted.

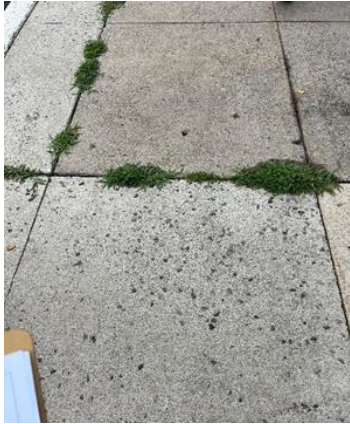
- 3) The overgrown vegetation needs to be treated across the entire facility. Specifically, the vegetation in between the sidewalk slabs in front of the building since this may pose a tripping hazard for pedestrians.

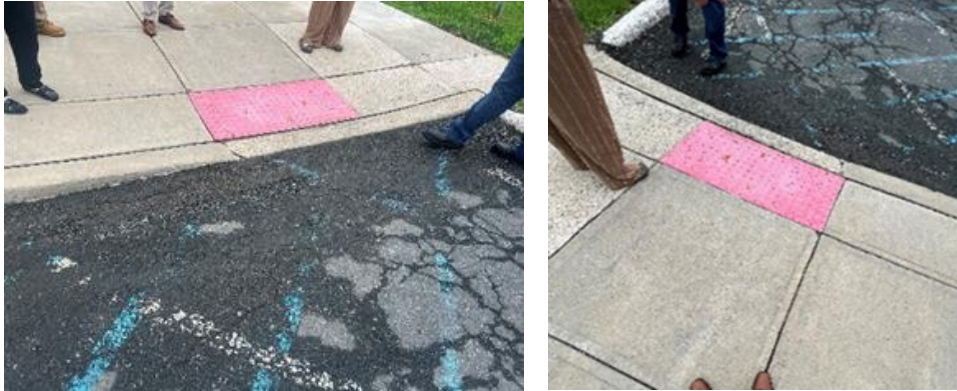
- 4) The new ADA curb ramp near the accessible portable toilets will need to be extended, along with the DWS.

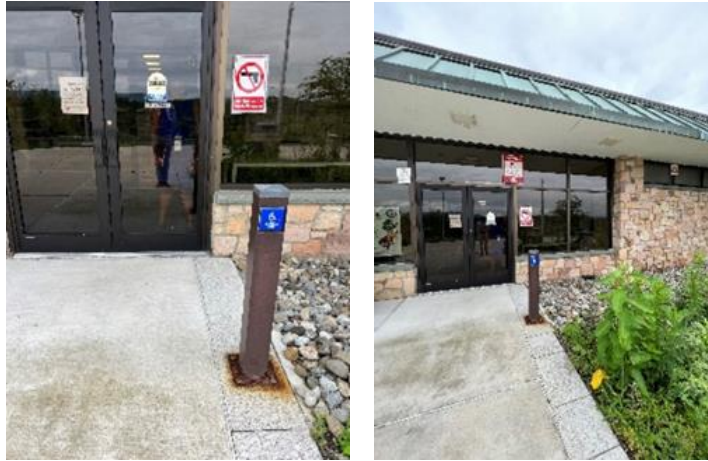
- 5) The back entrance is non-compliant with current ADA requirements. The accessible push-button is currently not active.

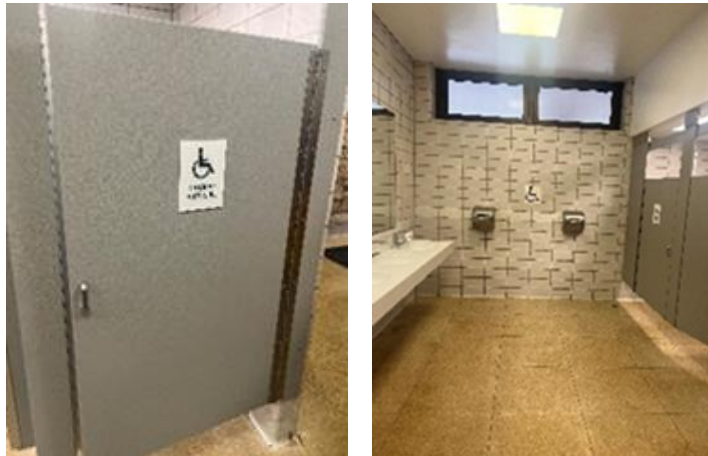
- 6) Both women and men's rest room accessible stalls need to be extended outward to provide enough clear space for accessibility.

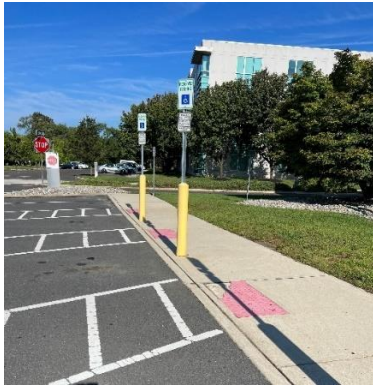
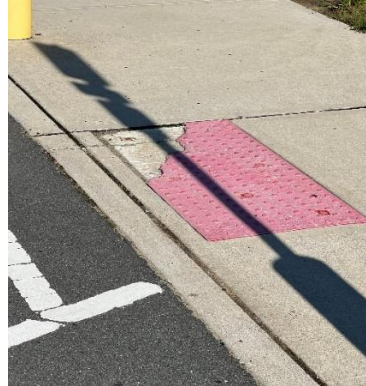
- 2) DWS mat will be replaced, it is chipped and is starting to deteriorate.

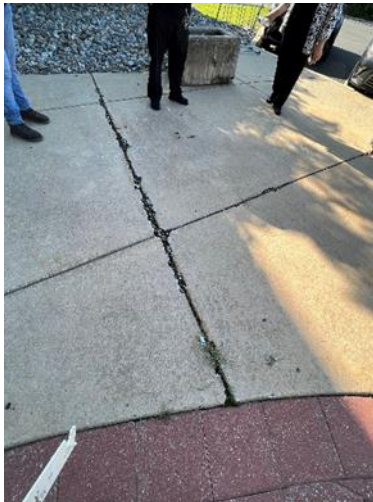
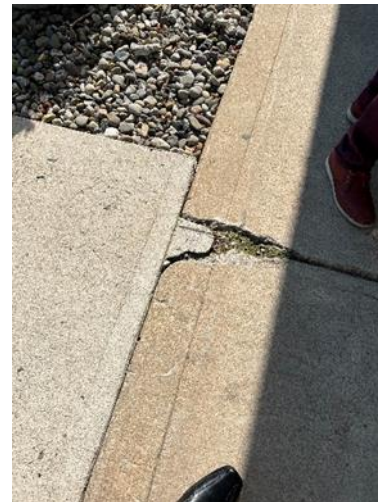
- 3) The front of the building has chipped/damaged concrete pads which could be a potential tripping hazard.

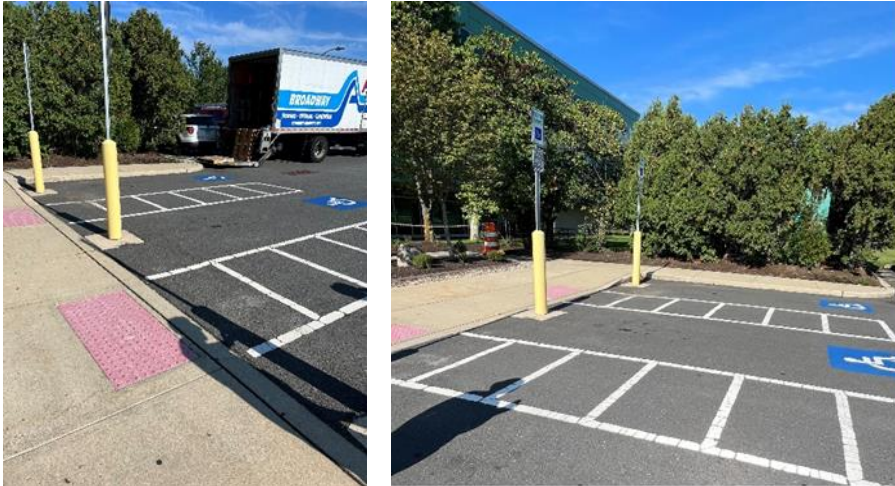
- 1) The accessible parking spots in the rear of the building will be extended to 18ft (length) for compliance with ADA requirements.

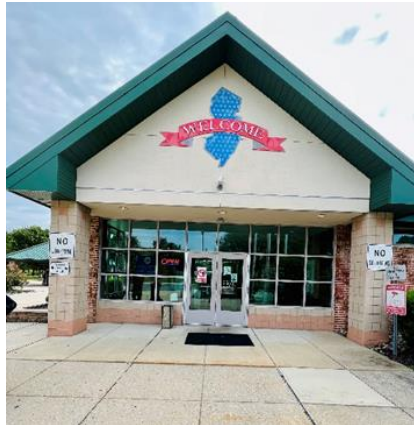
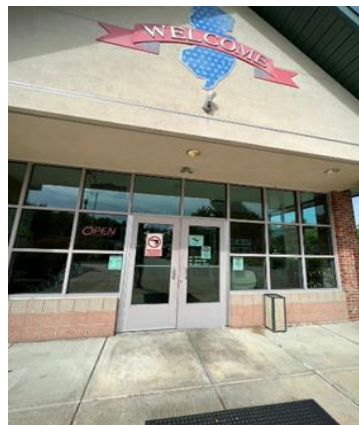
- 1) It is recommended that the front/back entrances be made accessible for all users. Accessible push-button doors will be installed for ADA accessibility.

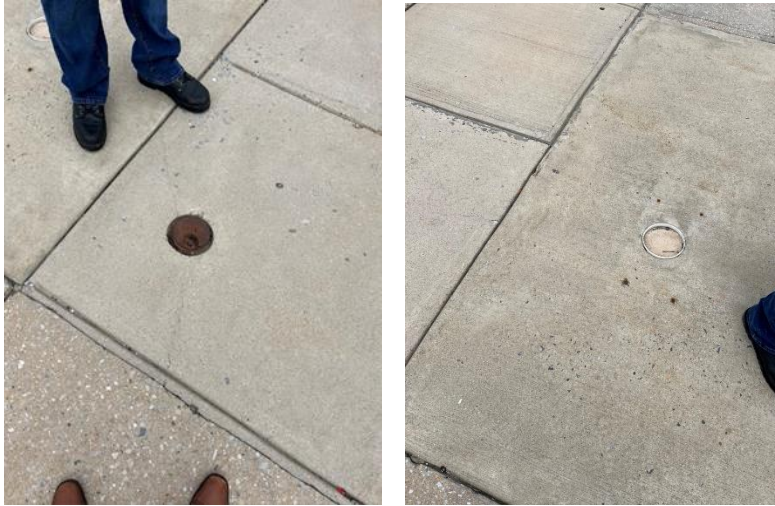
- 2) There are two tripping hazards from outdated piping in front of the building in the concrete pads that should be repaired.

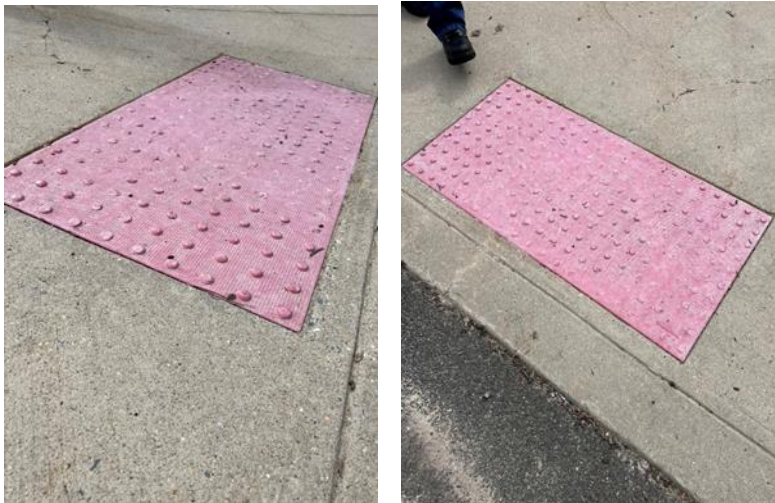
- 3) Detectable Warning Surfaces (DWS) in front of the building need to be replaced due to deterioration (2). There is one DWS in the back of the building that needs to be replaced as well. There are three DWS's in total that need to be replaced for compliance.

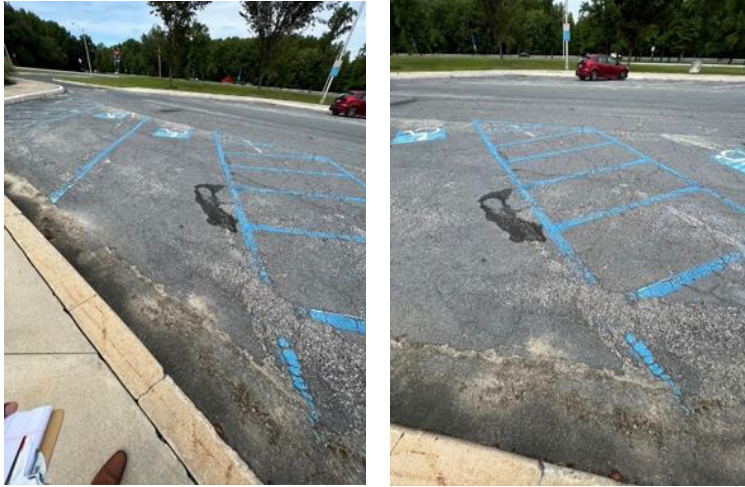
- 4) Accessible parking spaces need to be restriped.

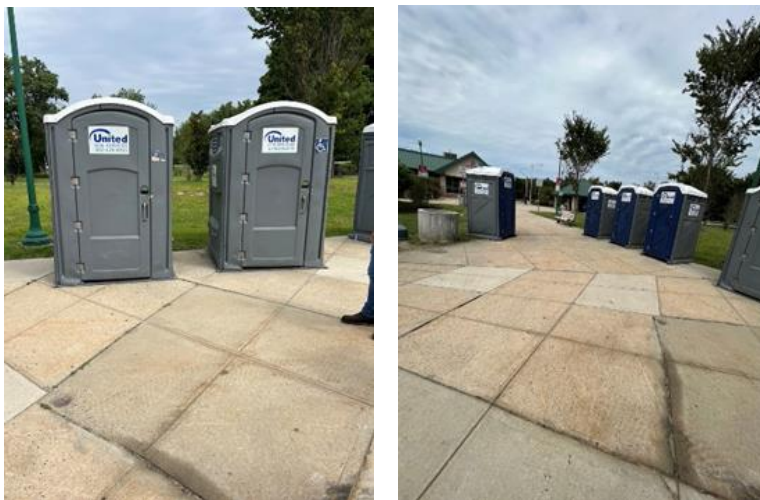
- 5) The concrete behind the second DWS in front of the building is steep for individuals using a wheelchair.

- 6) It is recommended that the curb in front of the building be reconstructed to a depressed curb. Also, there will be yellow bollards placed around accessible parking signs (for protection and bright identification.)
- 7) Handicap signs on the accessible portable toilets will be replaced for greater visibility.

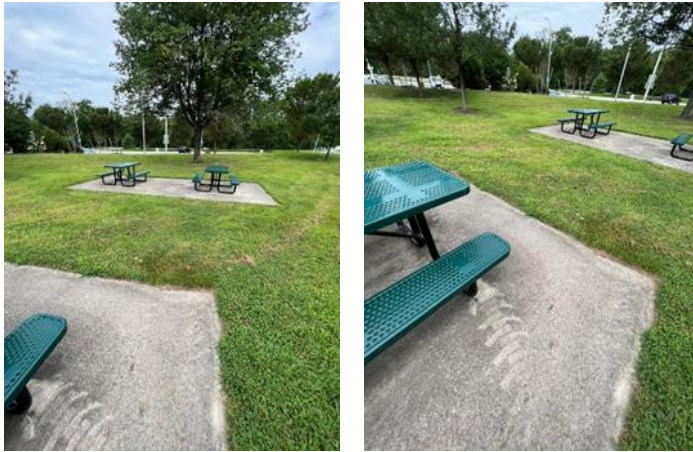
- 8) There are no ADA compliant picnic tables on the grounds. Facilities will add two picnic tables that are ADA accessible.

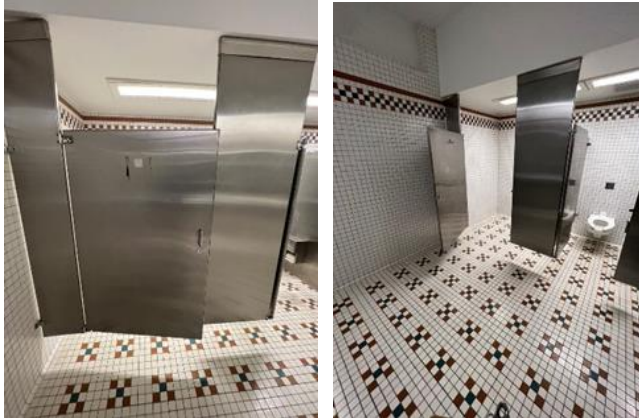
- 9) Accessibility sign should be installed on the women's rest room ADA stall.

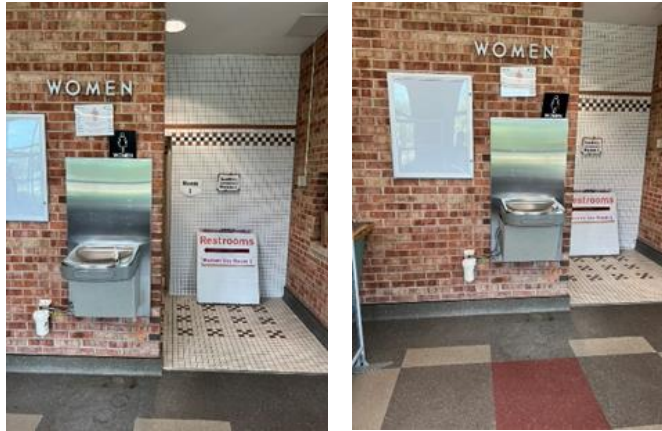
10) ADA signage should be installed outside of the women's rest room.
