NJDOT High Friction Surface Treatment (HFST) Guidance

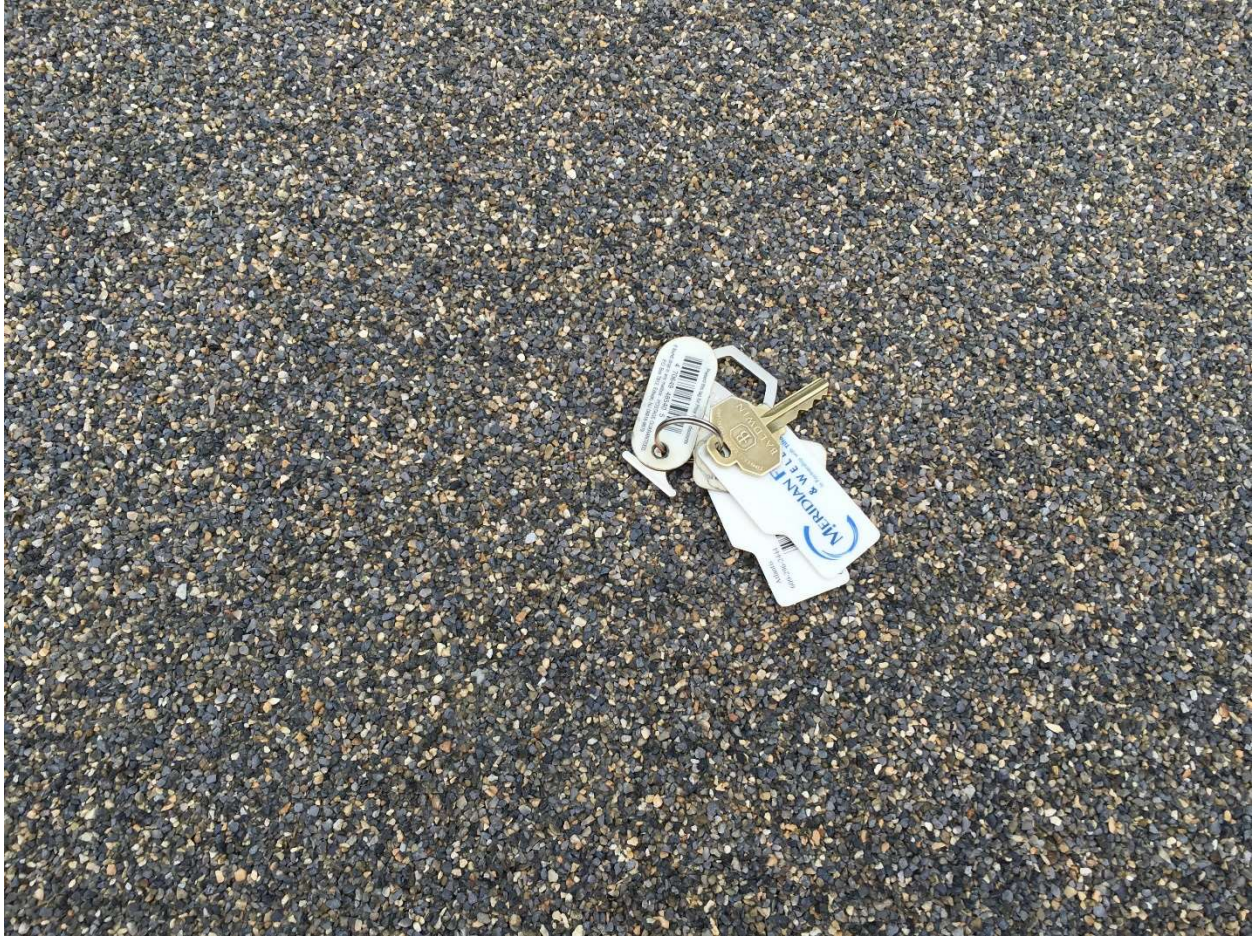
Figure 1 – High Friction Surface Treatment (HFST)

High friction surface treatment (HFST) is a safety enhancement that improves and/or restores pavement friction to reduce crashes. Many lane-departure and intersection crashes occur when vehicle speed and roadway geometry create a “friction demand” higher than can be achieved from the pavement surface. HFST (Figure 1) is a thin layer of high quality aggregate bonded to the pavement surface with a uniformly controlled application of polymeric liquid binder adhesive to increase the friction capacity of the pavement. American Association of State Highway and Transportation Officials (AASHTO) provides additional guidance for HFST in their provisional Standard Practice for High-Friction Surface Treatment for Asphalt and Concrete Pavements (PP 79) which requires specific materials and a minimum skid resistance value.

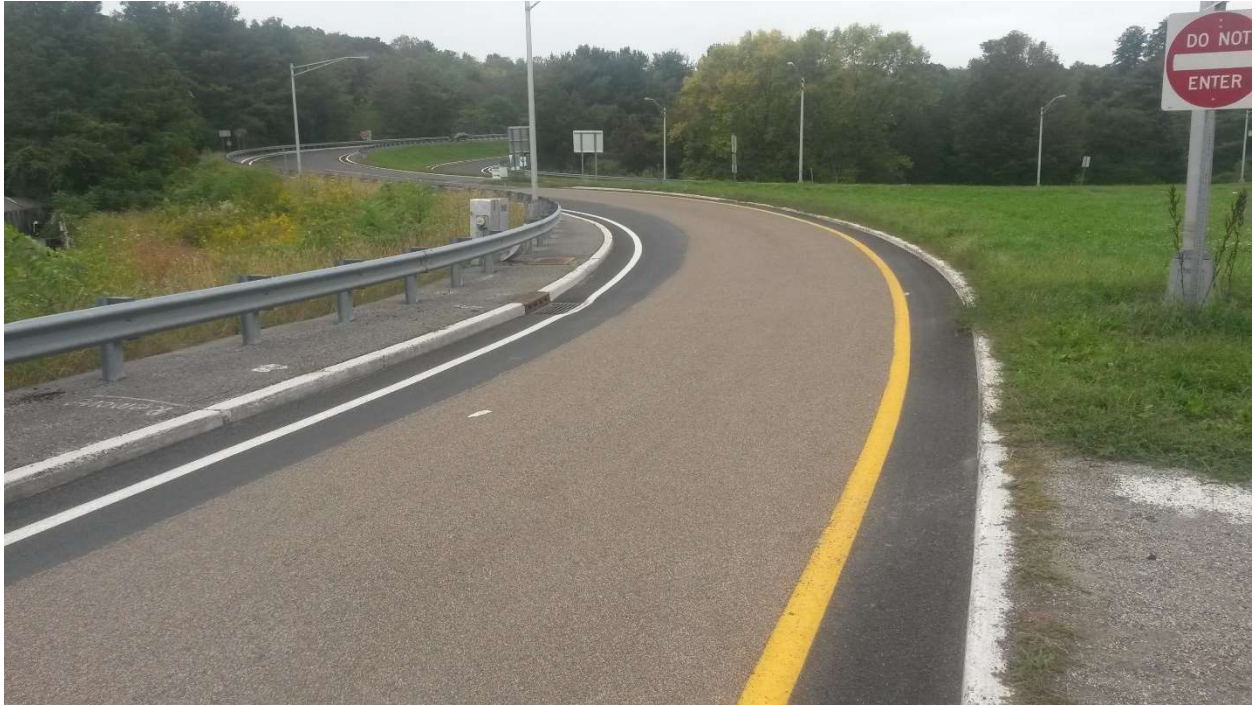
Figure 2 – HFST on Asphalt Surfaced Pavement

According to national research, HFST has a lifespan of 5 to 7 years under heavy traffic, and 10 to 15 years for low traffic. Most of the roadways in New Jersey are heavy traffic to very heavy traffic, especially the NJDOT roadway network. Therefore, to ensure the return on the HFST investment, locations selected for HFST application should be done so prudently and the underlying pavement should have a remaining service life (RSL) similar or greater than the expected life of the HFST. HFST is expensive and therefore should be placed only in locations that meet NJDOT criteria, which have good pavement condition and will yield the most return on the investment. NJDOT has some varying experience concerning how to evaluate and determine if a pavement is in “good” enough condition for applying HFST. Based on that experience, NJDOT determined that this guidance document was necessary to assist engineers and maintenance personnel in selecting appropriate pavement sections for HFST. This document is intended also to provide a systematic way to evaluate and repair the pavement when the surface condition is questionable and may not be suitable for HFST placement. HFST is only appropriate to install on structurally adequate and functionally sufficient pavements, which are considered in “good” condition. Pavements planned for preventive maintenance, resurfacing, rehabilitation or reconstruction should not be programmed for HFST without coordination with the planned work to make the most efficient use of funding. Pavements determined to be structurally adequate, smooth, exhibiting “good” surface condition (or functional sufficiency) with little to no surface distress, and are 2 years in age or less since the last surface placement may be considered for HFST. HFST may be installed over asphalt surfaced (Figure 2) and/or concrete surfaced (Figure 3) pavements.

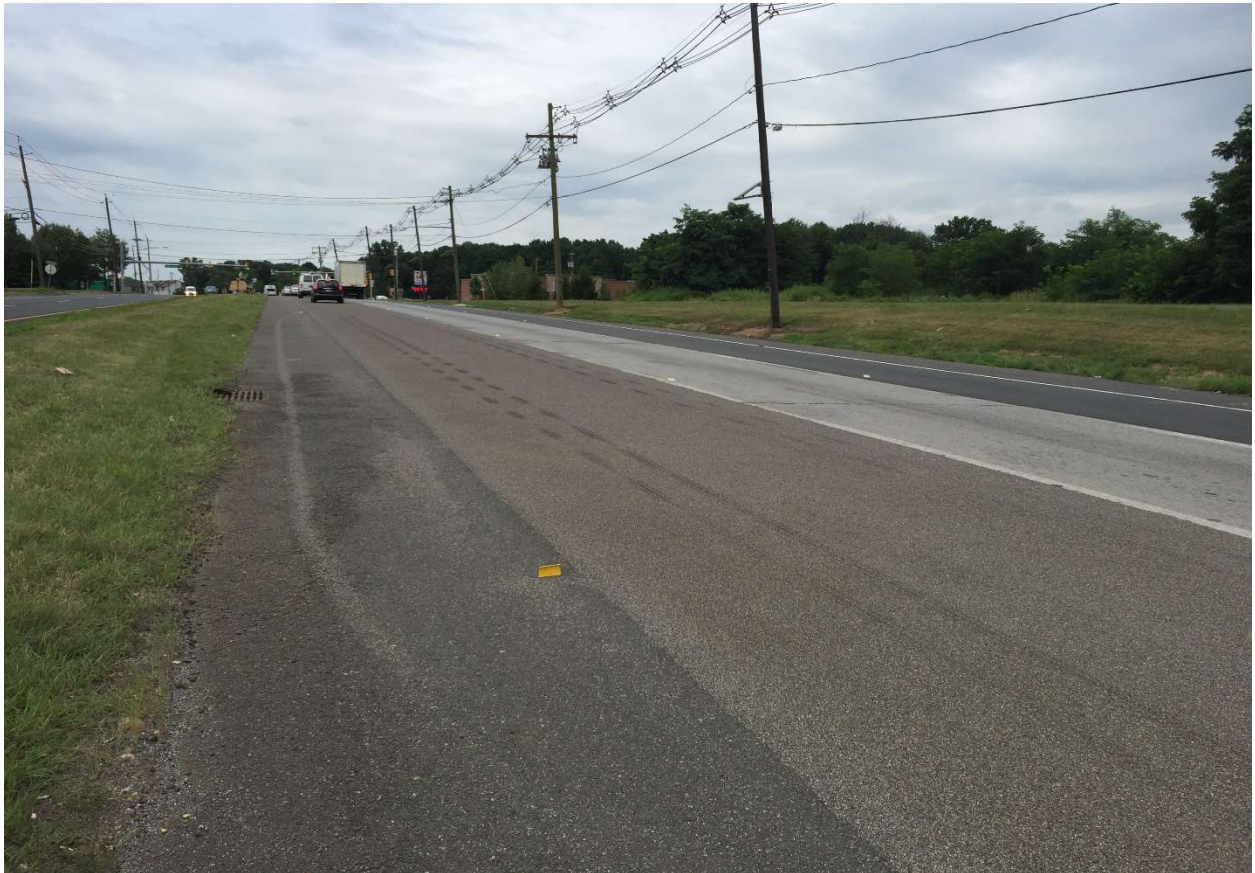
Figure 3 – HFST on Concrete Surfaced Pavement

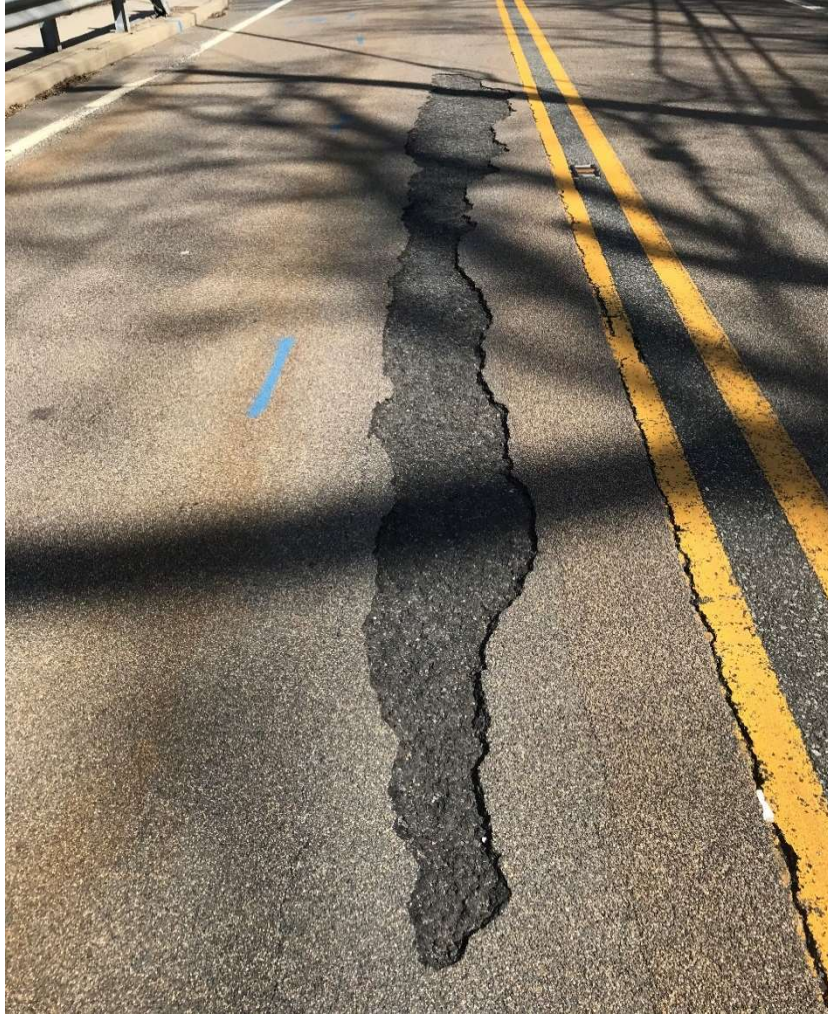
Figure 4 – Failure of HFST and Asphalt Substrate

2. **Coefficient of Thermal Expansion difference between HFST and asphalt substrate.** The increased stress in locations of high friction demand due to vehicle tire forces and environmental stress induced by thermal cycling. The difference in the coefficient of thermal expansion (COTE) between the HFST polymeric resin binder, COTE between 14 and $30 \times 10^{-6}/^{\circ}\text{F}$, and the asphalt pavement surface, COTE between 7 and $9 \times 10^{-6}/^{\circ}\text{F}$, has been shown to induce stress with thermal cycling (Wilson and Mukhopadhyay, 2016) between the HFST binder and the weak asphalt. This added stress to the pavement can accelerate asphalt deterioration leading to asphalt failure and thus HFST failure as shown in Figure 4 and Figure 5.

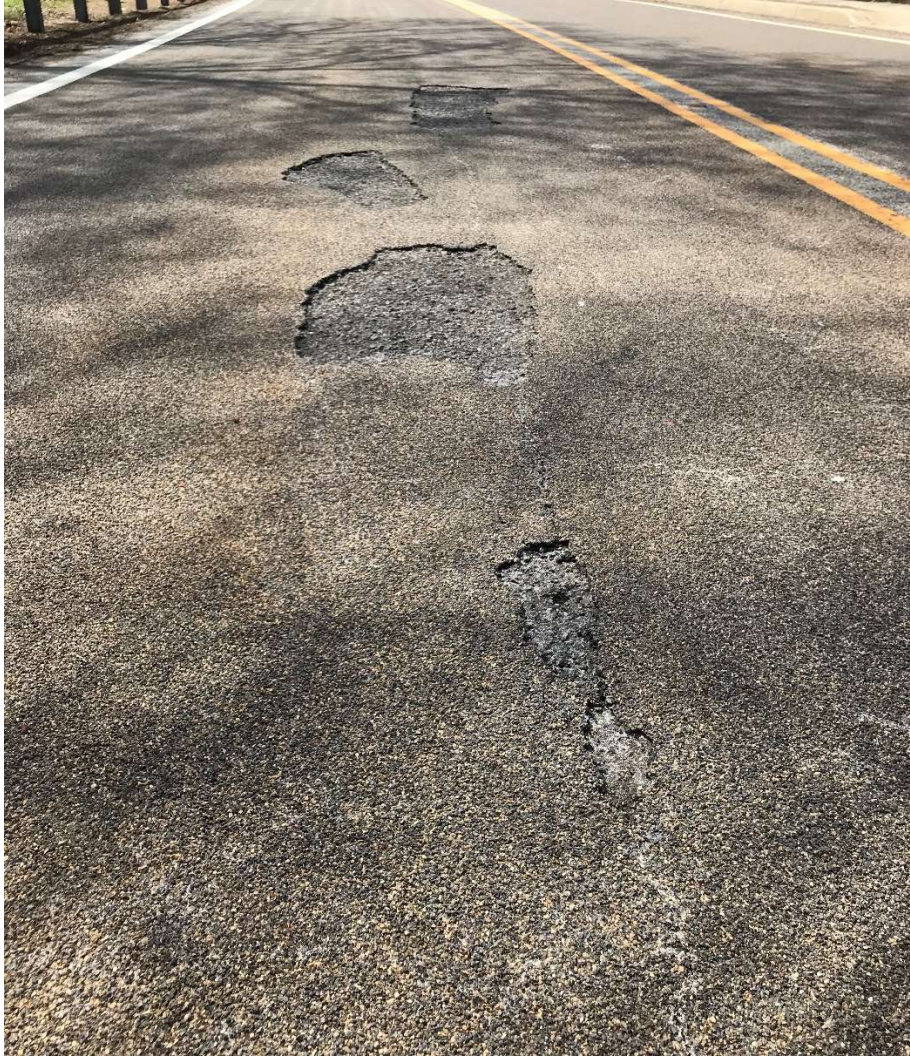
Figure 5 – Failure of HFST and Asphalt Substrate

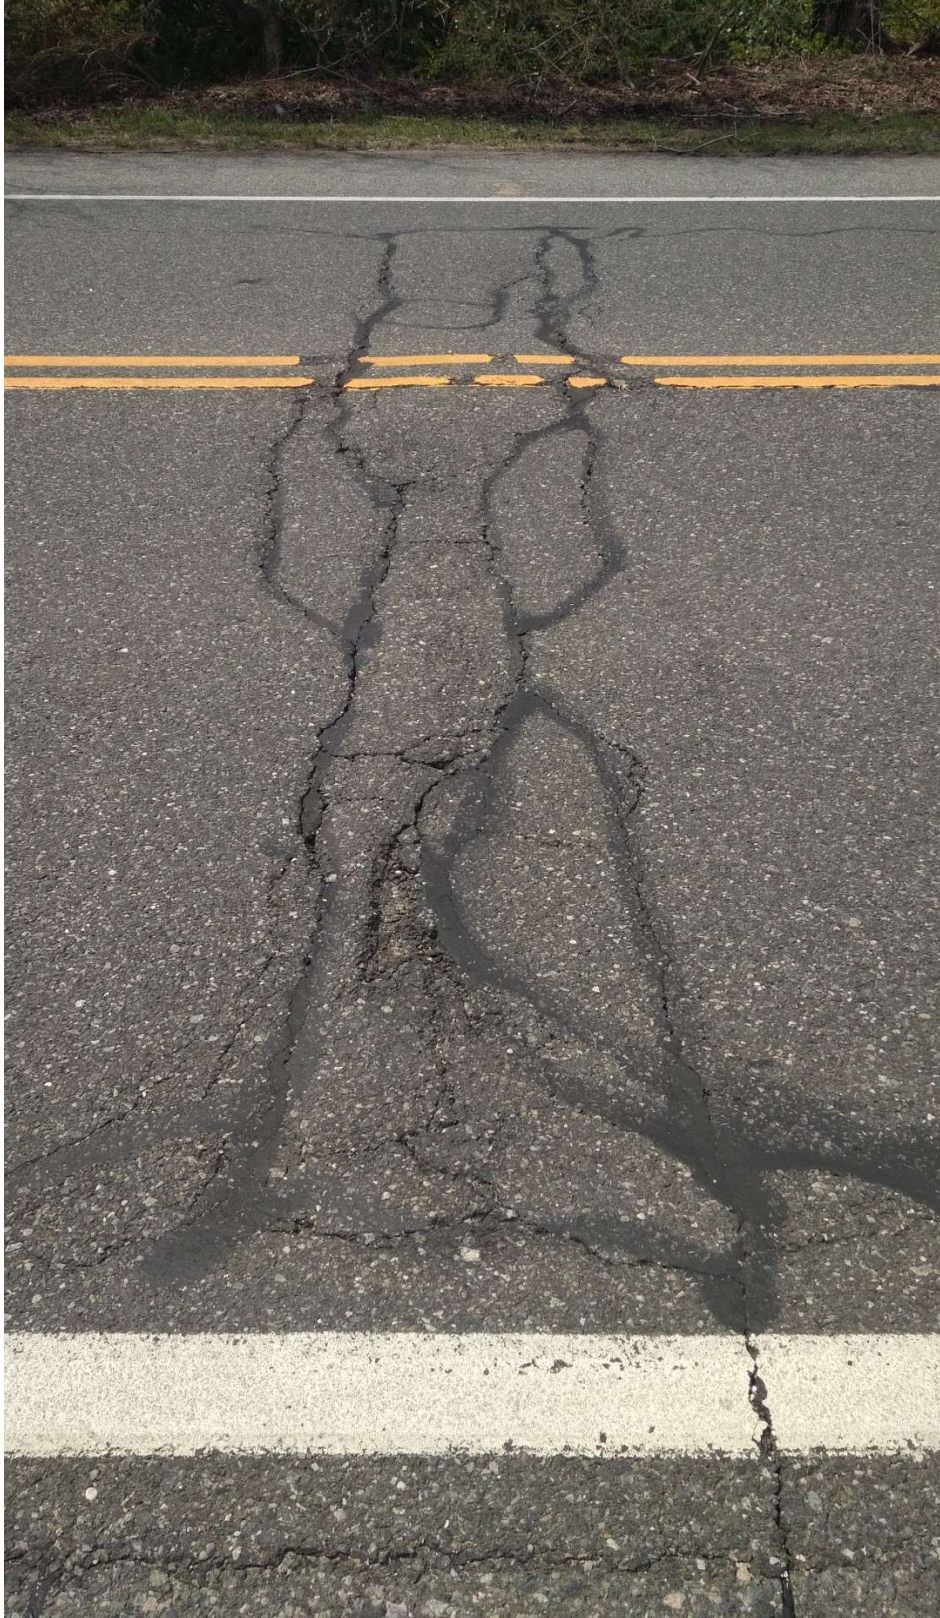
Figure 6 – High Severity Reflective Cracking of Asphalt over a Concrete Pavement Joint (Composite Pavement) Area Requiring Repair

- Longitudinal cracks inside the wheel path of vehicles, localized high severity cracks (Figure 6), or interconnected cracks, using an appropriate approved HMA surface course and good construction practices that meet NJDOT standards.

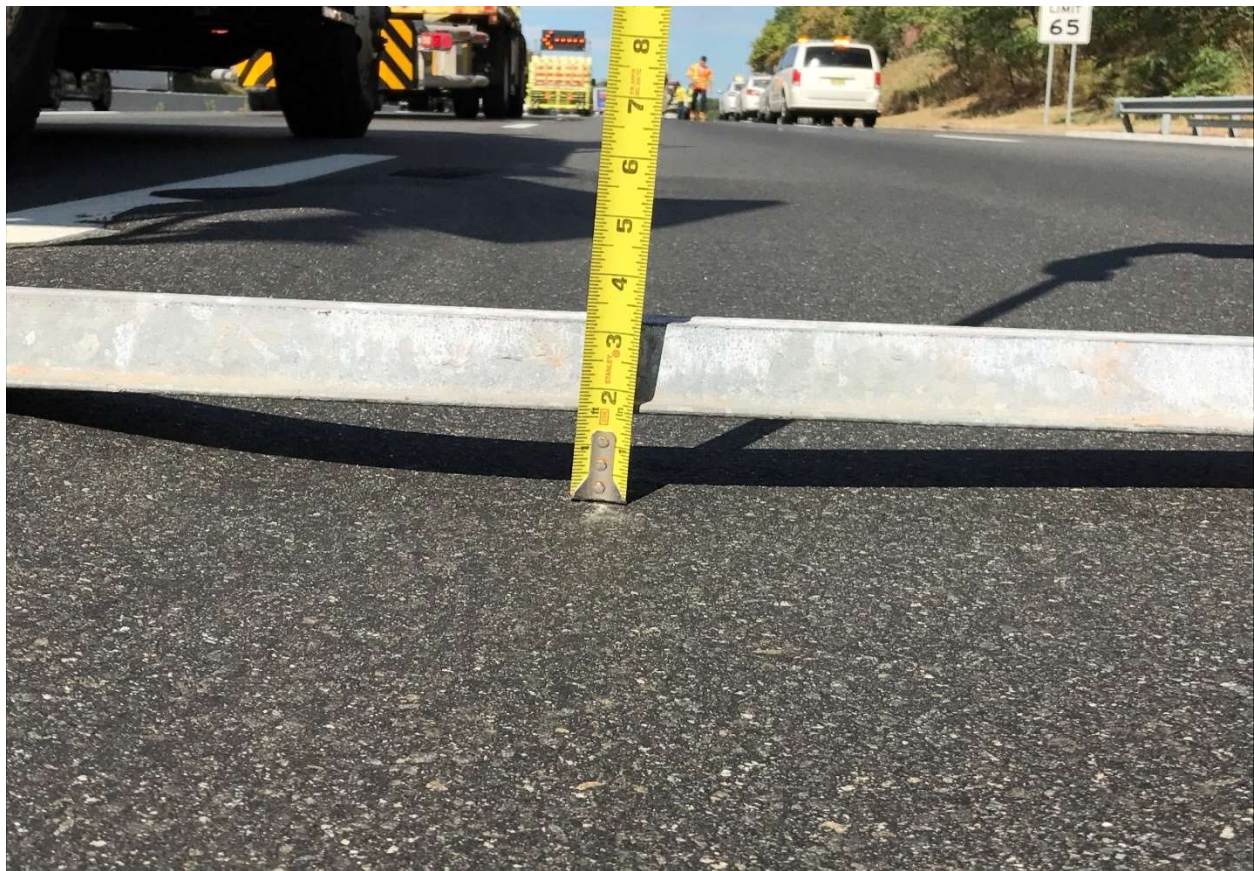
Figure 7a. – Asphalt Rutting in the Wheel Path that Requires Repair

- Rutting of 0.25" to 1" depth may be micro-milled or diamond ground to smooth the surface and ensure consistent HFST binder thickness.
 - Rutting greater than 1" depth (Figure 7) will, as a minimum, require milling and resurfacing to remove and replace the full width and depth of the affected layer(s) with approved asphalt pavement materials. A pavement evaluation should be performed to determine the cause of rutting. An experienced pavement engineer should review the pavement evaluation. The pavement engineer will then issue a pavement design recommendation that may require milling and resurfacing, pavement structural rehabilitation or pavement reconstruction.

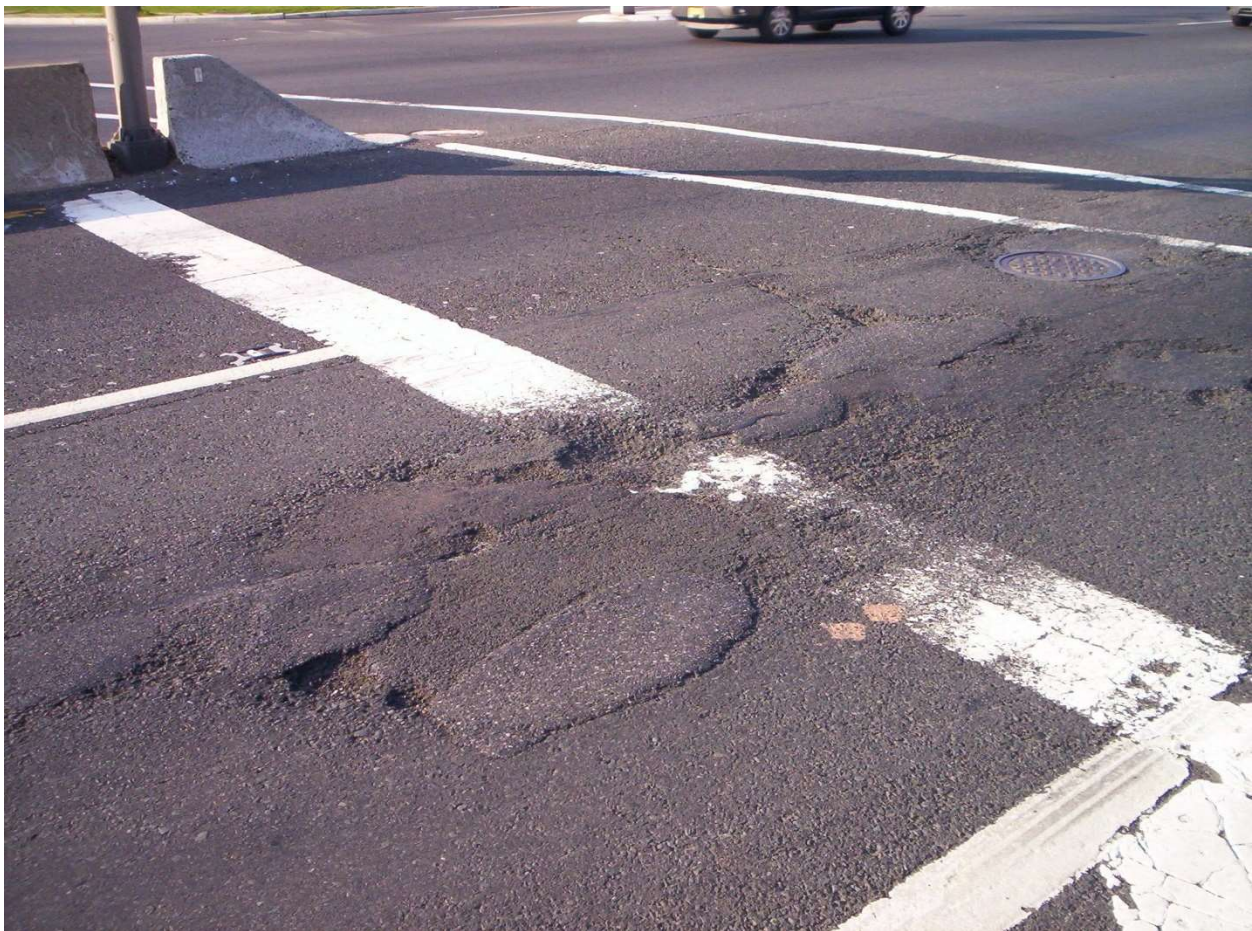
Figure 8 – Asphalt Potholes, Unsound Patching and Raveling Requiring HMA Pavement Repair or Milling and Resurfacing

- When pothole frequency and density becomes too high (Figure 8), this indicates a performance or structural issue with the pavement. Mill and resurface to remove and replace the full depth of the affected layer(s) in these areas with the required pavement structure and approved asphalt pavement materials.

- When patch frequency and density becomes too high (Figure 8), this indicates a performance or structural issue with the pavement. Mill and resurface to remove and replace the full depth of the affected layer(s) in these areas with the required pavement structure and approved asphalt pavement materials.

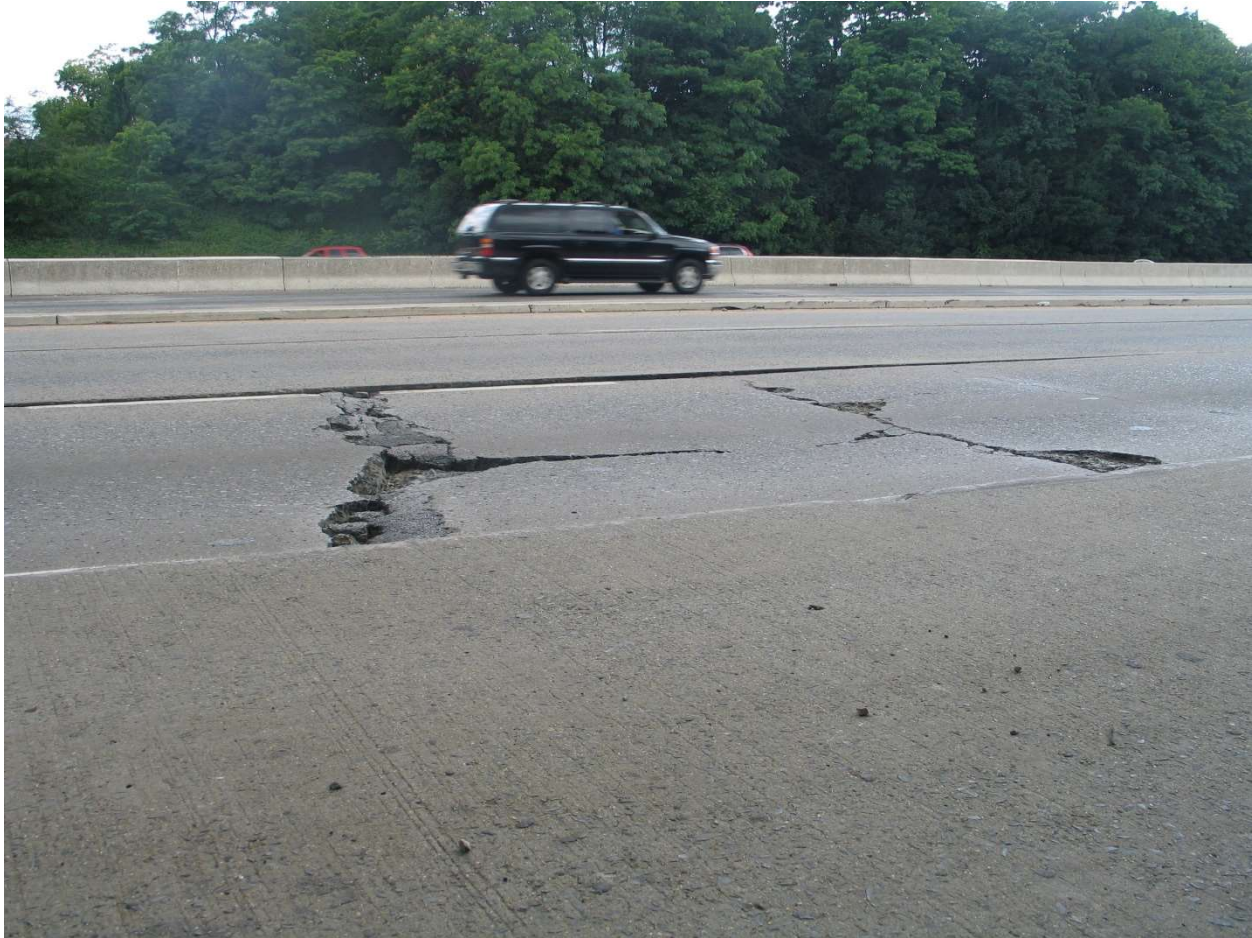
Figure 9 – High Severity Concrete Distress (High Severity Cracking, Spalling, Potholes and Faulting) Requiring Full Depth Slab Repair

- **Cracking.** No structural cracking should be present (Figure 9). Few low severity non-structural cracks may be acceptable such as tight transverse cracks and joints outside the wheel paths of vehicles. Non-structural cracks that have spalling are not acceptable for HFST. The total percentage of low severity non-structural surface cracking should be less than 1 percent.

- **Faulting.** No faulting (Figure 9).
 - Concrete faulting is a serious safety concern that needs to be repaired prior to applying HFST.
 - Faulting of 0.25" to 1" depth may be micro-milled or diamond ground to smooth and level the surface. A smooth and level surface will ensure a more consistent HFST binder thickness.

- Rutting greater than 1" depth will require removal and replacement of the affected panel(s).
- **Potholes.** No potholes (Figure 9) in the surface.
