A Publication of the New Jersey Department of Transportation

Dennis Creek Landing Update: Remains of Earlier Bridge Discovered During N.J. Route 47 Reconstruction

Project: Replacement of N.J. Route 47 Bridge over Dennis Creek
Location: Route 47 from Route 83 to north of Dennis Creek, Dennis Township, Cape May County
Date: Summer 2000; 2005-08
Consultant: Hunter Research, Inc., 120 West State Street, Trenton, NJ 08608

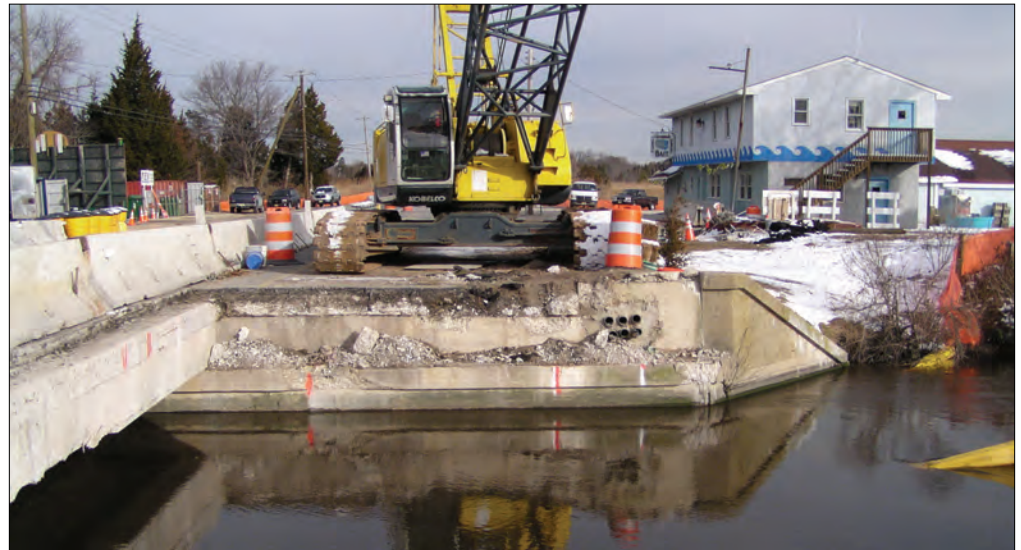
View looking north showing the north abutment of the bridge built in 1928 being removed in January 2006 [Source: Hunter Research, Inc.].

When the bridge built in 1928 was replaced in 2005-06, an archaeologist was present to observe all ground-disturbing activity, including the removal of the foundations of the existing bridge. This was accomplished by the construction of four temporary cofferdams using interlocking sheet pilings that were driven into the creek and the banks. The water was then pumped out, and each cofferdam was excavated

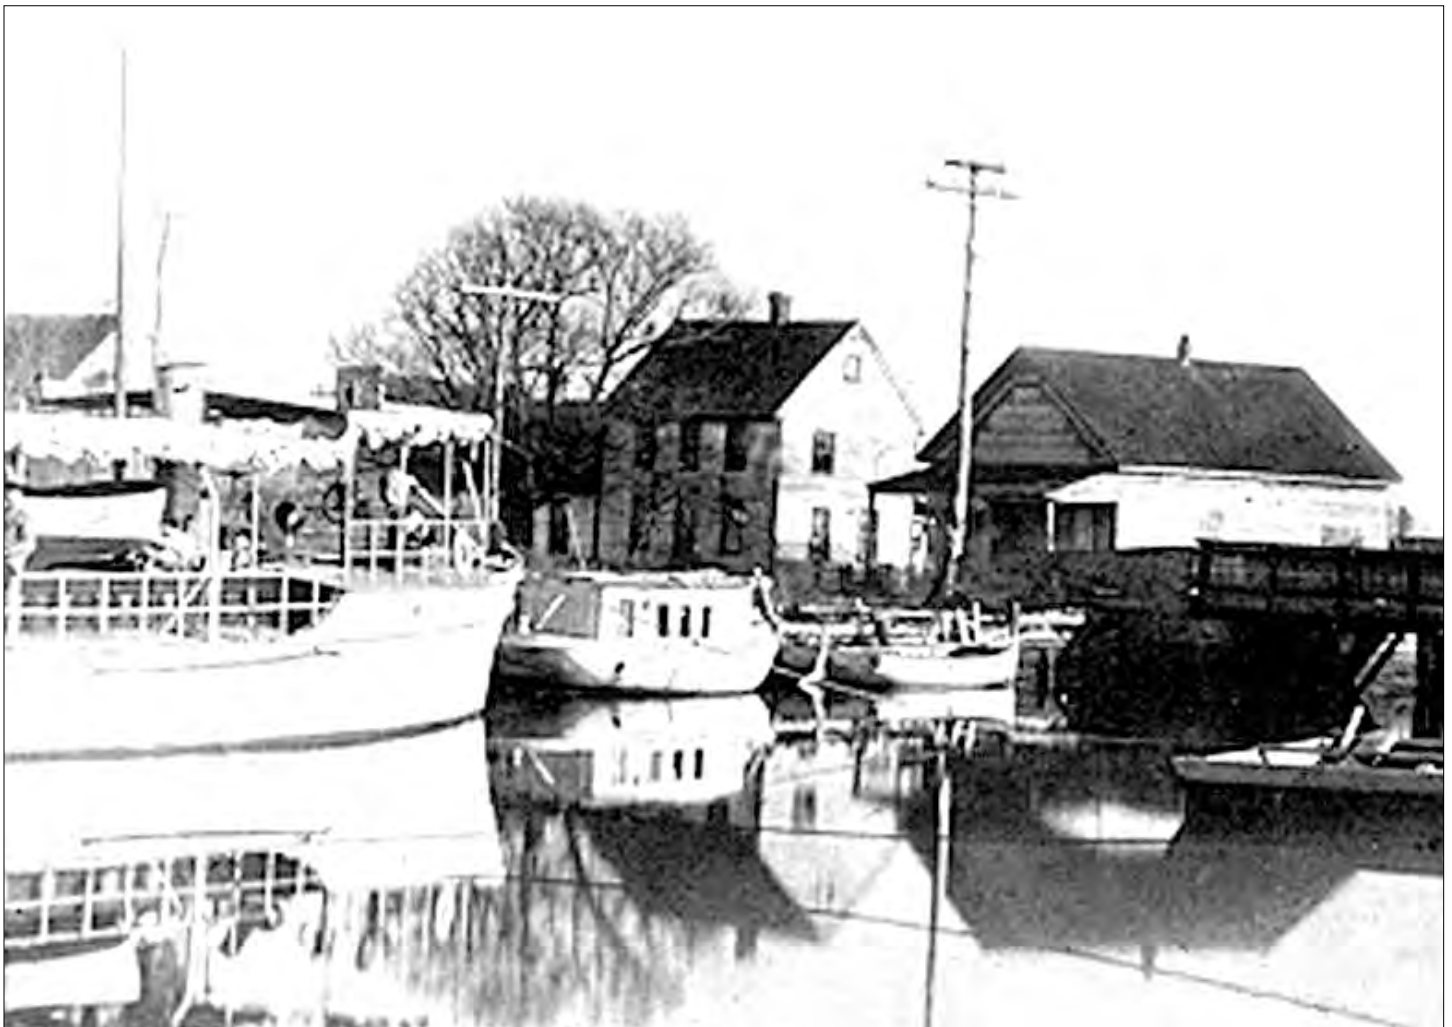
Dennis Creek Landing about 1915. The wooden bridge over Dennis Creek, at right, was built in 1885 and replaced in 1908 [Source: George Brewer, Jr.].

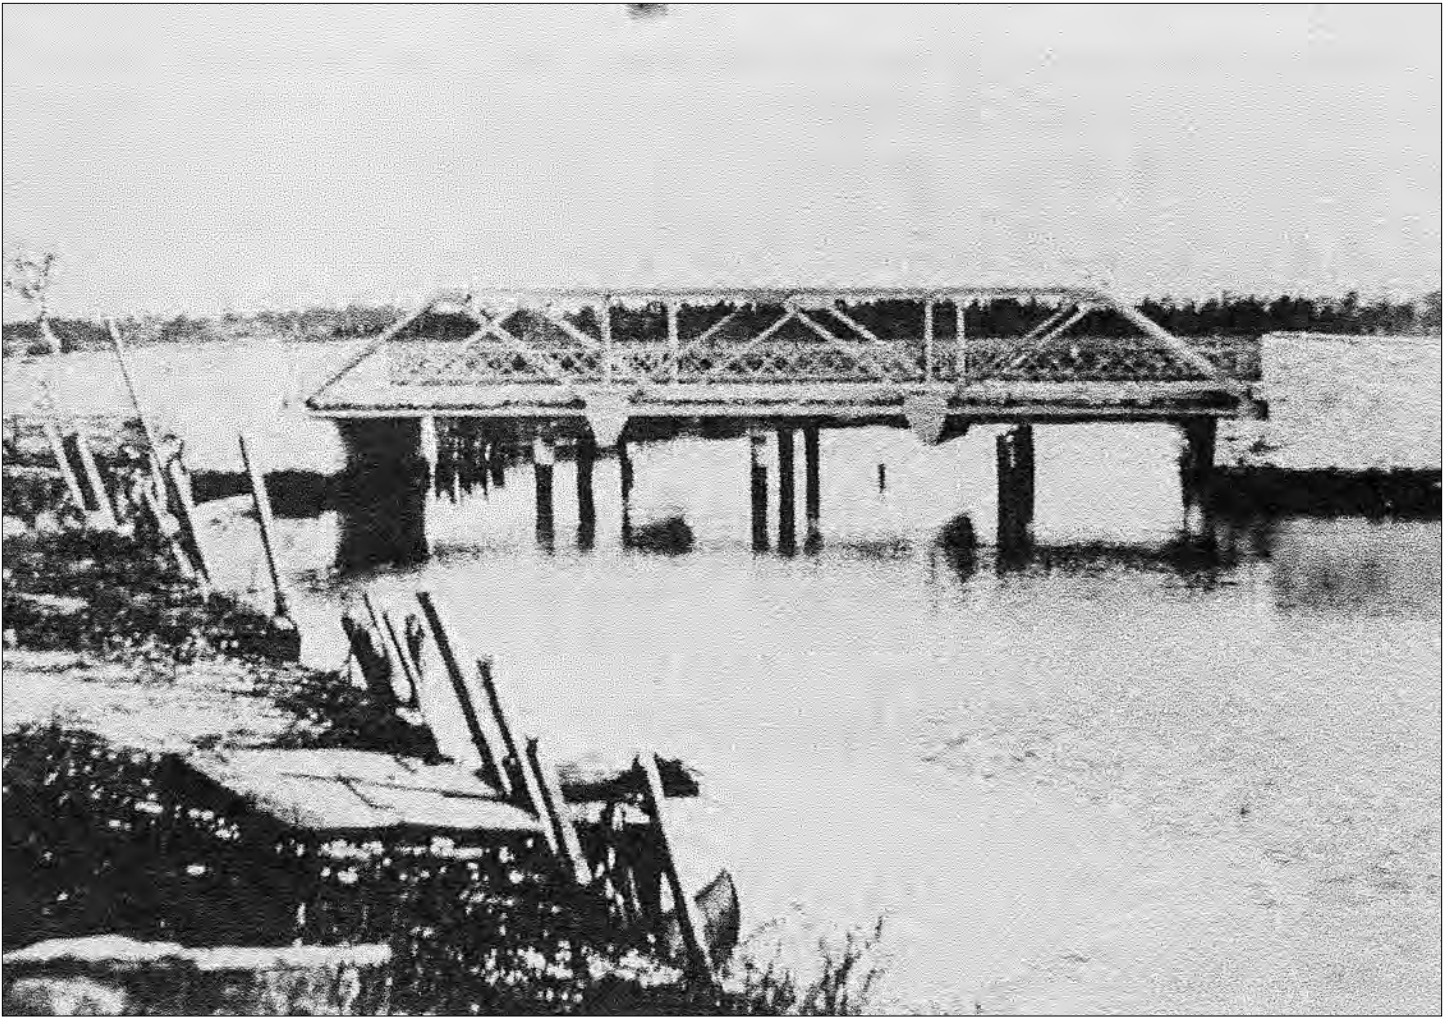
The pony truss bridge over Dennis Creek at Dennis Creek Landing about 1925. This bridge was built in 1908 and replaced in 1928 [Source: George Brewer, Jr.].

In 1908, the bridge built in 1885 was replaced, this time by a steel pony truss. Pony trusses are not as tall as through trusses and have no top cross-members, so vehicles of any height can use them. They were used for shorter crossings and were designed for lighter loads than through trusses. The Dennis Creek Landing pony truss was photographed at least twice, and in one of these views it appears that the pilings from its predecessor bridge had been left in place. They are clearly not supporting the new steel bridge.

The planks and posts lying on the creek bed were interpreted as possibly being remains of wharves known to have lined the creek. The vertical pilings turned out to be arranged in two rows, oriented north-south and about 17 feet apart. In all likelihood these related to one of the earlier bridges, probably the wooden bridge built in 1885, and these may be the same posts that appear in the photograph of the pony truss that succeeded it.

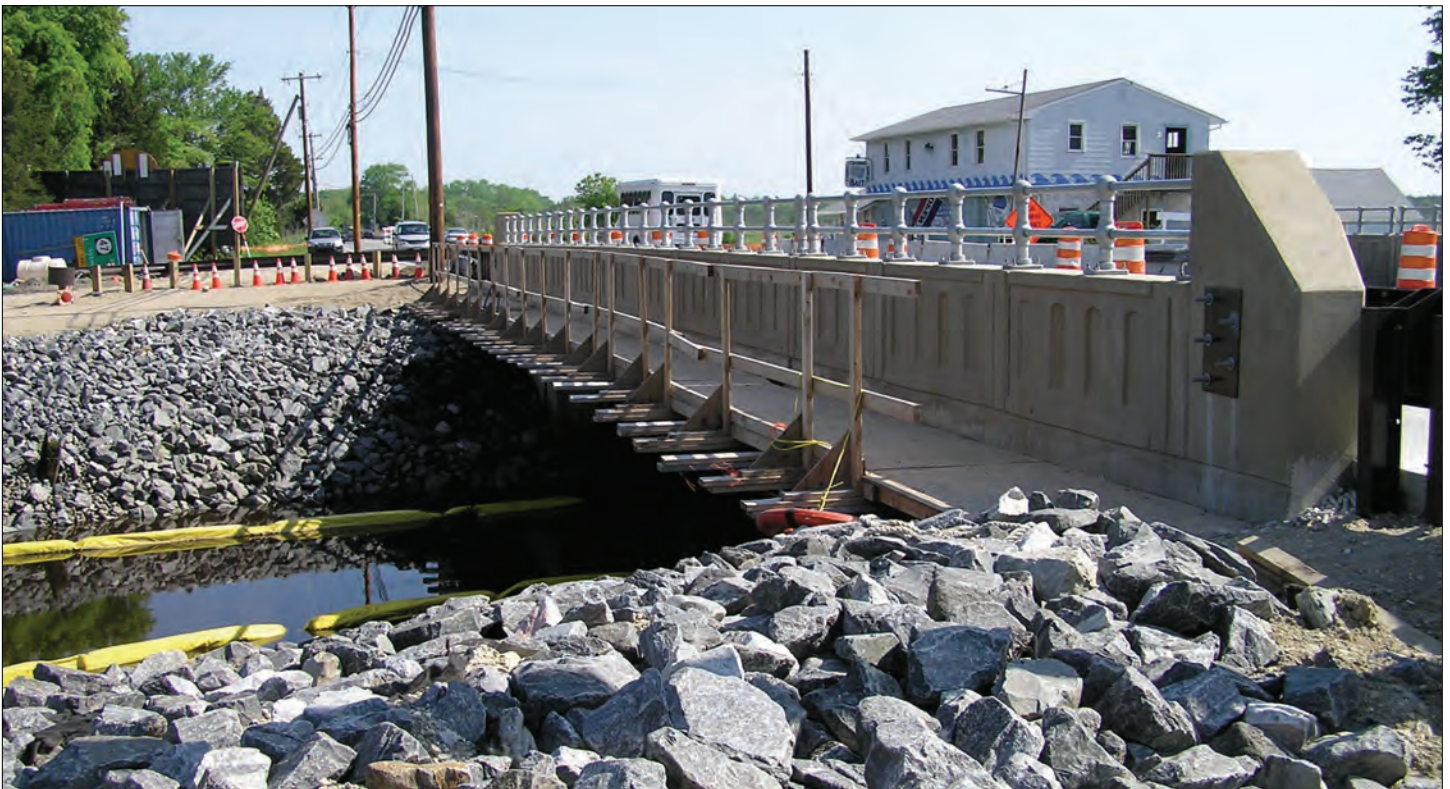
View looking north showing the new bridge near completion in May 2007 [Source: Hunter Research, Inc.].
