PROJECT PURPOSE

The purpose of the I-80 Rockfall Mitigation Project (Milepost 1.04 to 1.45) is to increase safety and improve the mobility of the traveling public by preventing rockfall incidents.

NEW JERSEY DEPARTMENT
OF TRANSPORTATION
www.njdot.nj.gov

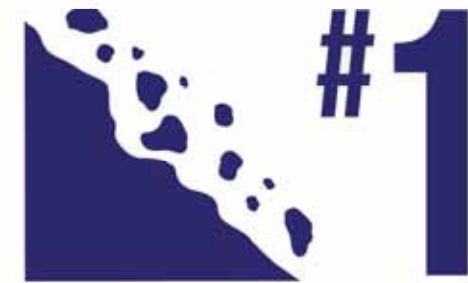
ROCKFALL HAZARD LOCATION IN THE STATE

Based on a system developed by the Federal Highway Administration

- NJDOT maintains a Rockfall Hazard Management System
- Utilizes FHWA Rockfall Hazard Rating System
- Inventories 440+ rock slopes adjacent to NJ interstates & highways
- Preliminary and detailed ratings group slopes by addressing the likelihood of rockfall reaching the roadway surface
- Design approach hierarchy:
 - Remove
 - Stabilize
 - Protect

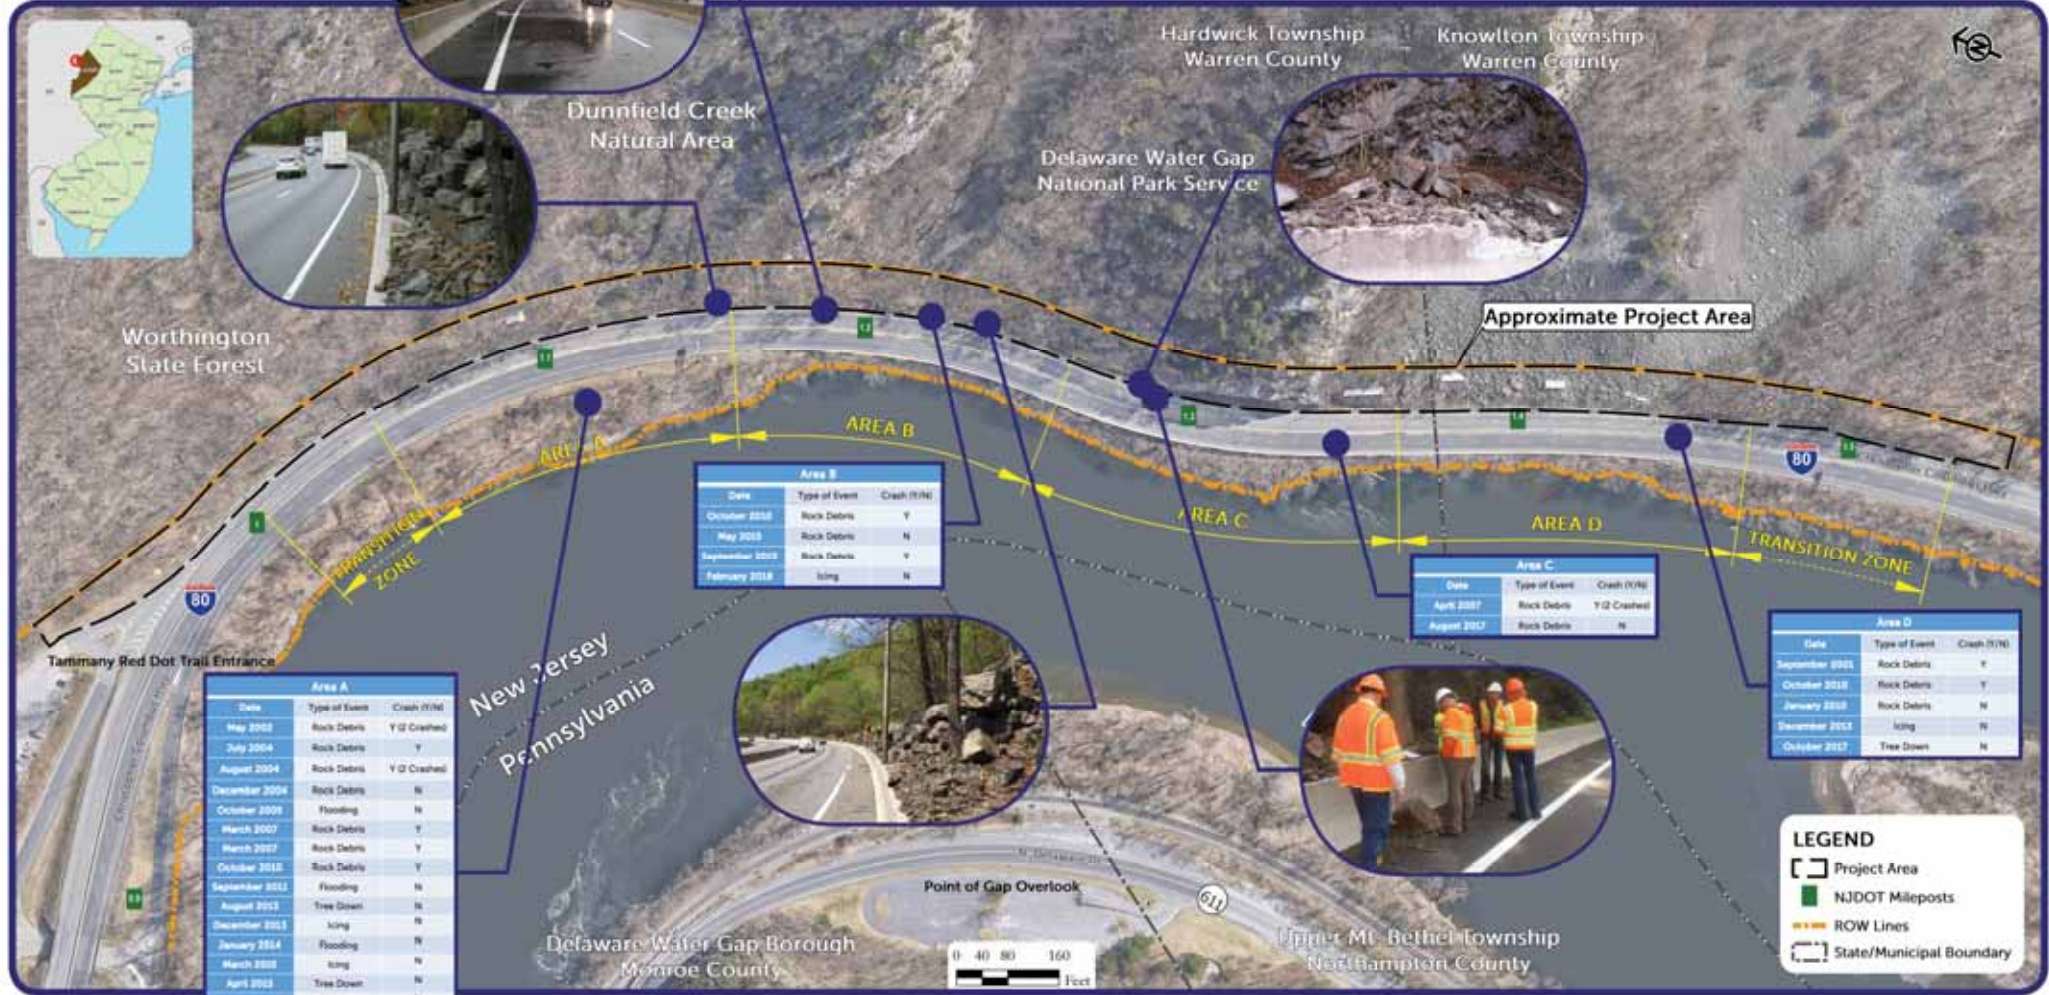
ROCKFALL INCIDENTS

Area A		
Date	Type of Event	Crash (Y/N)
May 2002	Rock Debris	Y (2 Crashed)
July 2004	Rock Debris	Y
August 2004	Rock Debris	Y (2 Crashed)
December 2004	Rock Debris	N
October 2006	Flooding	N
March 2007	Rock Debris	Y
March 2007	Rock Debris	Y
October 2010	Rock Debris	Y
September 2012	Flooding	N
August 2013	Tree Down	N
December 2013	icing	N
January 2014	Flooding	N
March 2018	icing	N
April 2018	Tree Down	N
September 2018	Tree Down	N
July 2017	Tree Down	N
January 2018	icing	N
February 2018	Flooding	N

Area B		
Date	Type of Event	Crash (Y/N)
October 2018	Rock Debris	Y
May 2015	Rock Debris	N
September 2013	Rock Debris	Y
February 2018	icing	N

Area C		
Date	Type of Event	Crash (Y/N)
April 2007	Rock Debris	Y (2 Crashed)
August 2007	Rock Debris	N

Area D		
Date	Type of Event	Crash (Y/N)
September 2001	Rock Debris	Y
October 2018	Rock Debris	Y
January 2018	Rock Debris	N
December 2013	icing	N
October 2017	Tree Down	N
